Re: *United States v. Ionia Management S.A.*  
Index No. 07-cr-134 (JBA)  
Response to Special Master's Letter, dated November 11, 2009  
CO&D Ref: 500172.0002

## Report of Ionia's Progress – December, 2009

**3. Pollution incident, 17 September, 2009 at Antwerp. The issues from the Antwerp incident to be addressed include:**

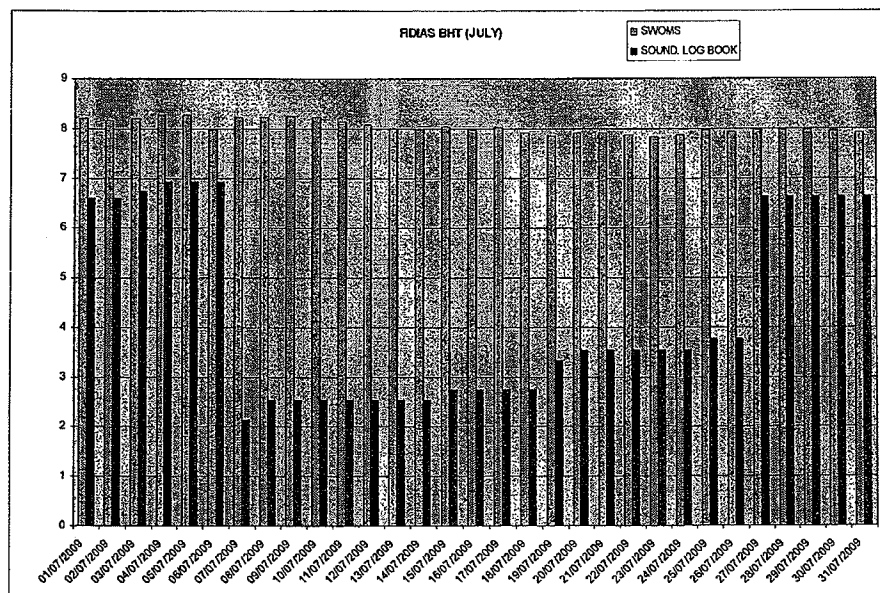
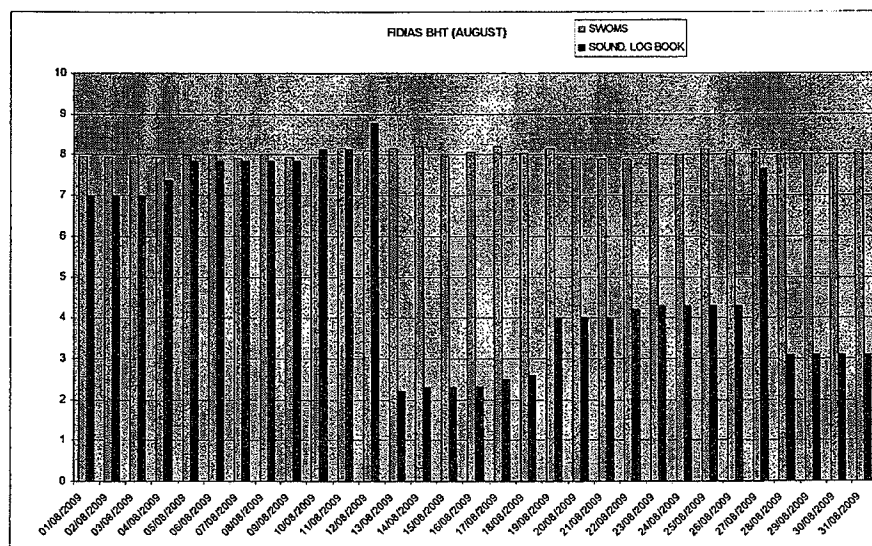
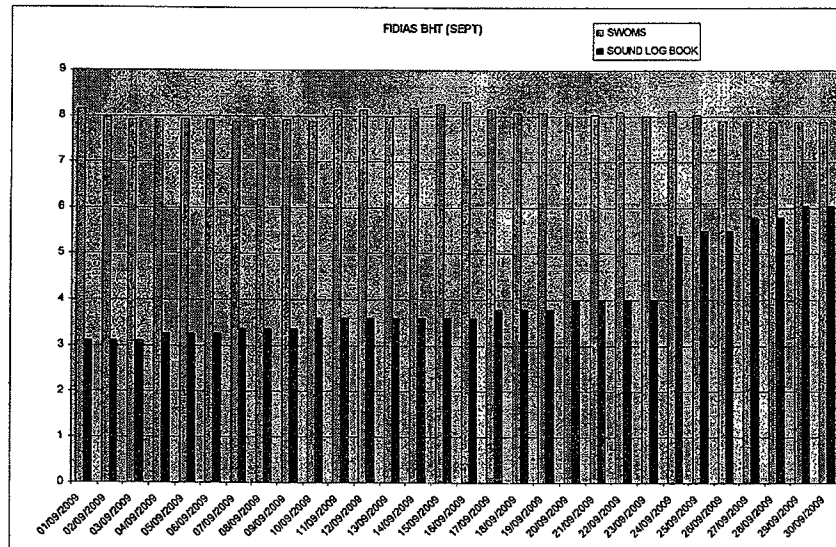
The sensor in the vessel's Bilge Holding Tank is currently not functioning. As the vessel had been trading in West Africa, technicians were not able to attend the vessel in order to resolve the issue. On the 16<sup>th</sup> of November, 2009 the vessel called at Piraeus and Ashland technicians attended the vessel. However, they were not able to resolve the problem due to a failure of their equipment.

Due to the sensor's malfunction, the Technical Superintendent is unable to utilize the SWOMS data that is transmitted for the specific tank. In order to verify the accuracy of the entries that are made in the Oil Record Book Part I, the remaining data that is submitted by the vessel is reviewed and all necessary calculations are made in order to ensure to the best of the Technical Superintendent's ability that there are no apparent irregularities in the data that is completed by the vessel.

Figure 1 M/T FIDIAS – Bilge Holding Tank – July 2009

Figure 2 M/T FIDIAS – Bilge Holding Tank – August 2009

Figure 3 M/T FIDIAS – Bilge Holding Tank – September 2009

- ii) Discrepancies that indicate that the sensor in the specific tank is not functioning. Please see Figures 1, 2 and 3.
- iii) Consistent discrepancies attributed to incorrect calibration of the SWOMS sensor that however allows the tank sounding level recorded to be monitored adequately. Please see Figures 4, 5, 6 and 9.

When discrepancies indicate that a tank's sensor has been rendered inoperative, arrangements are made for specialized technicians to attend the vessel in order to resolve the issue at the first convenient opportunity. The responsible Technical Superintendent ensures that all entries in the Oil Record Book Part I are accurate and in accordance with tank sounding entries and the engine room alarm print outs.

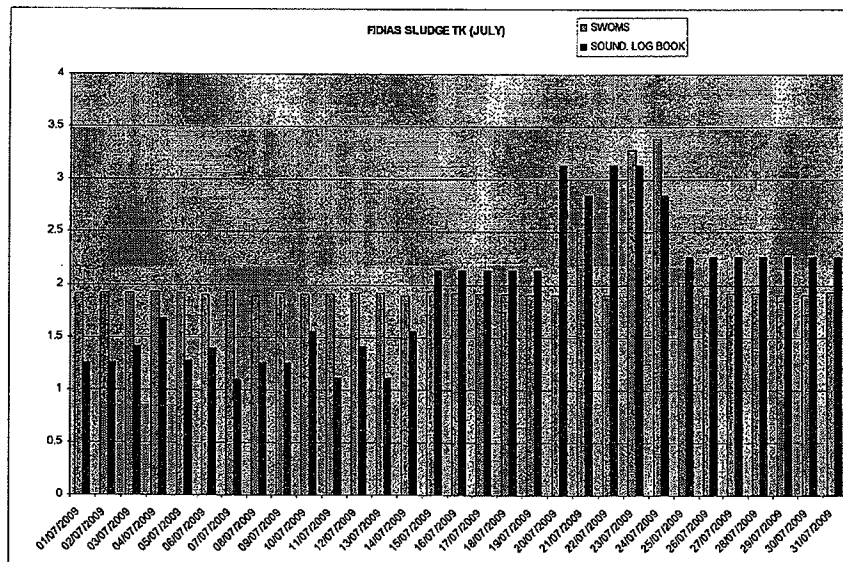
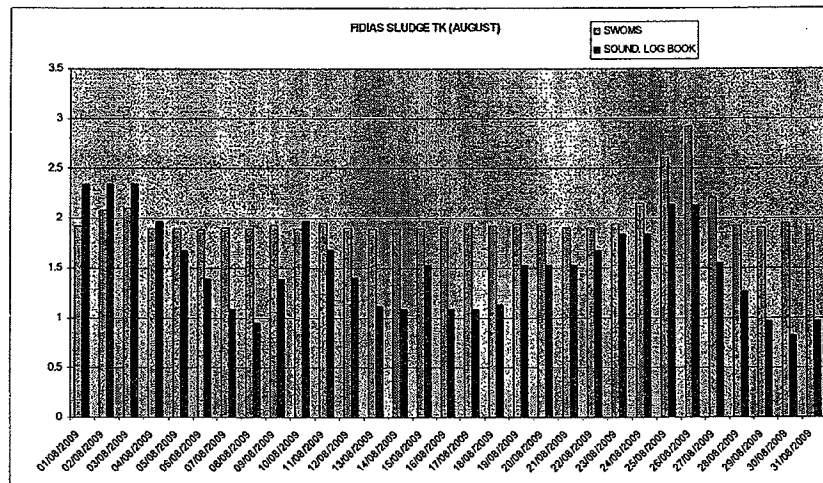
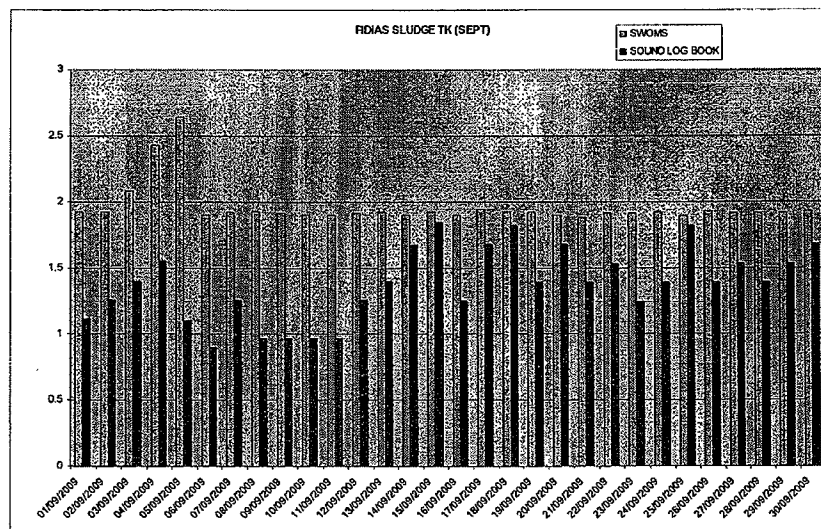
Figure 4 M/T FIDIAS – Sludge Tank – July 2009

Figure 5 M/T FIDIAS – Sludge Tank – August 2009

Figure 6 M/T FIDIAS – Sludge Tank – September 2009

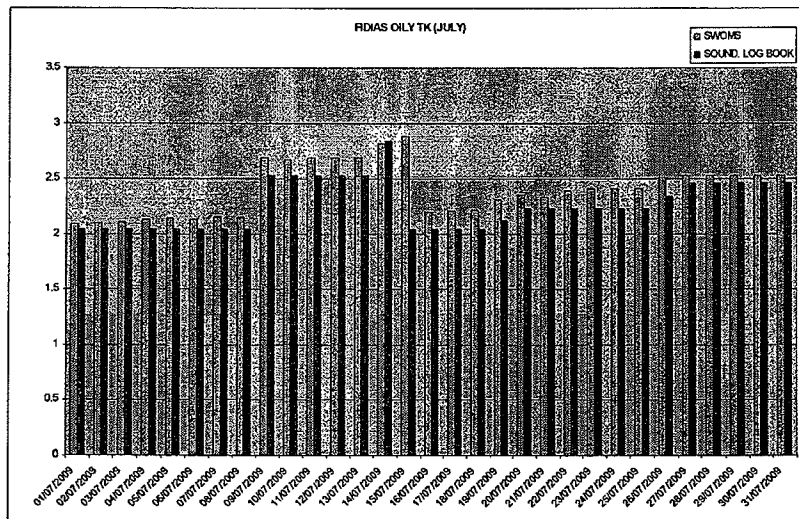
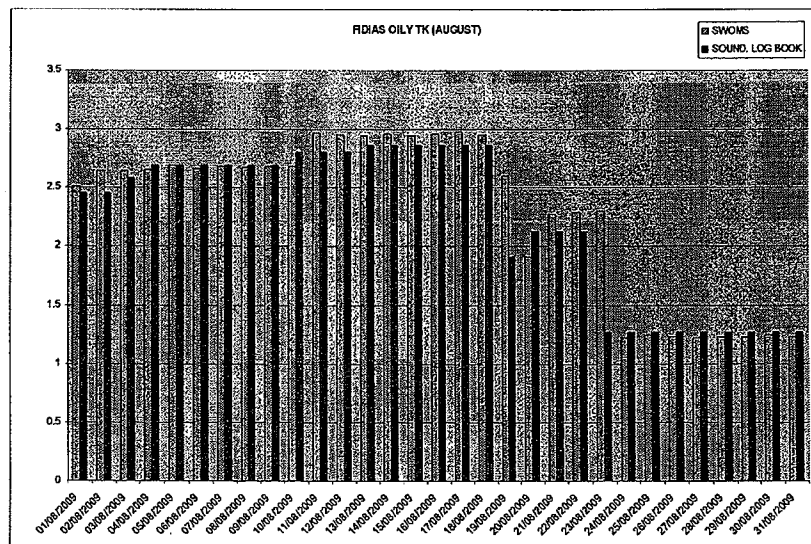
Figure 7 M/T FIDIAS – Oily Bilge Tank – July 2009

Figure 8 M/T FIDIAS – Oily Bilge Tank – August 2009

- v) Minor discrepancies within the allowable limit of 5% as per the unit's manufacturer. Please see Figures 7, 8, 13, 14, and 15.

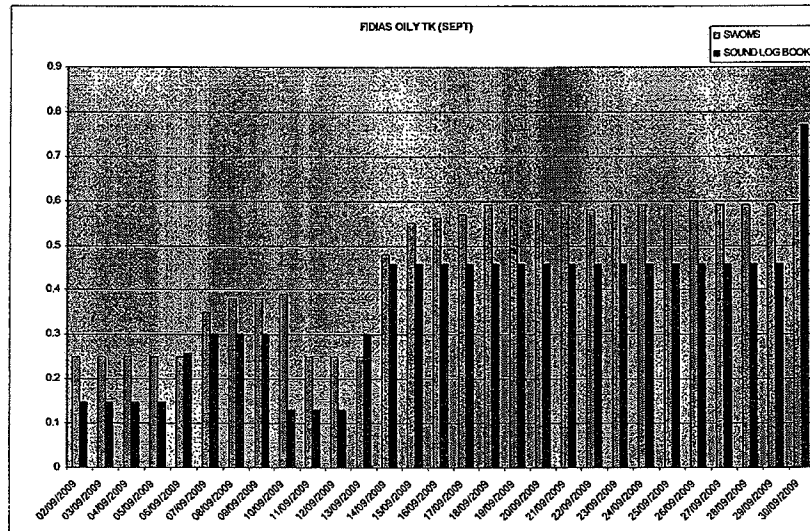
Figure 9 M/T FIDIAS – Oily Bilge Tank – September 2009

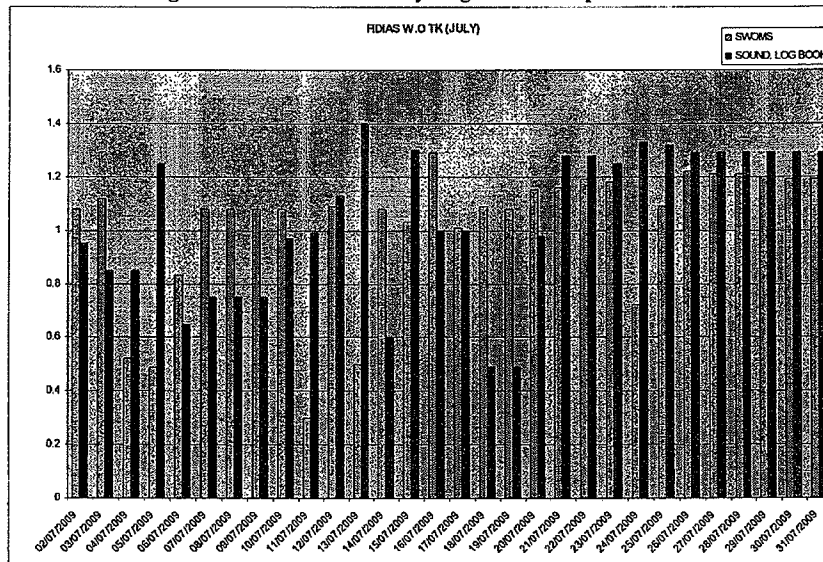
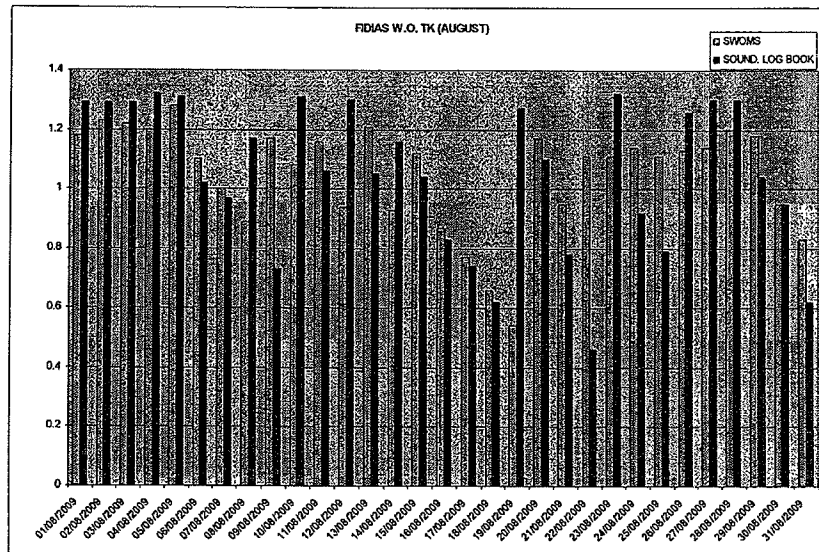
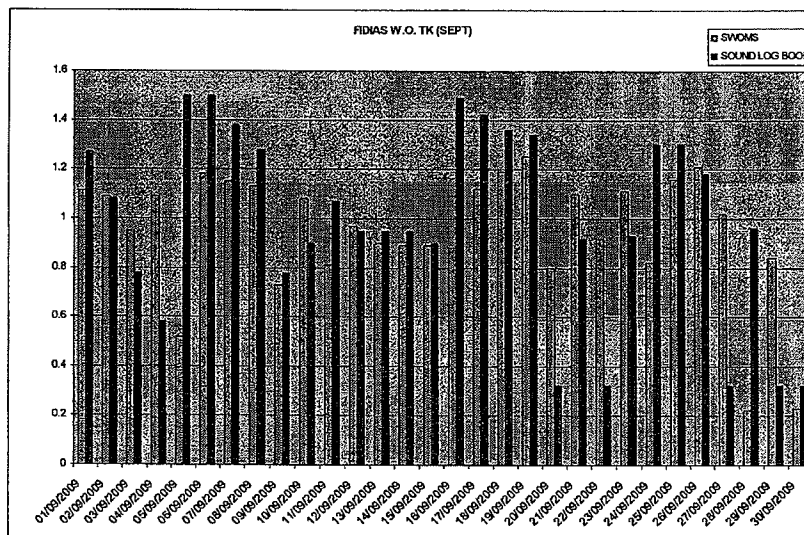
A further issue that has been encountered concerns the incinerator waste oil tank soundings that are recorded by the SWOMS. Due to the small dimensions (approximately 1,5m<sup>3</sup>) of the tank and the frequent operations that are carried out such as transfers, draining and evaporation, the SWOMS is not able to accurately record the level of waste in this particular tank. As this issue is a result of the size and nature of the incinerator waste oil tank, a solution to ensure accurate recoding is not readily available.

Figure 10 M/T FIDIAS – Incinerator Waste Oil Tank – July 2009

Figure 11 M/T FIDIAS – Incinerator Waste Oil Tank – August 2009

Figure 12 M/T FIDIAS – Incinerator Waste Oil Tank – September 2009

- iv) Discrepancies between the readings recorded by the SWOMS of the incinerator's waste oil tank and the actual soundings that are carried out manually. Please see Figures 10, 11, 12, 22, 23 and 24.

The discrepancies that have been identified regarding the readings of the waste oil incinerator tank have been investigated and are attributed to the following factors:

- a) The nature of the incinerator waste oil tank results in a number of operations such as transfers, draining and evaporation to be carried out within a 24 hour period. The SWOMS does not have the ability to take these operations into account resulting in inaccurate readings.
- b) The tank is small resulting in inaccurate readings.

Technicians have boarded the vessels to resolve the issue, however results have not been satisfactory and discrepancies continue to be observed.

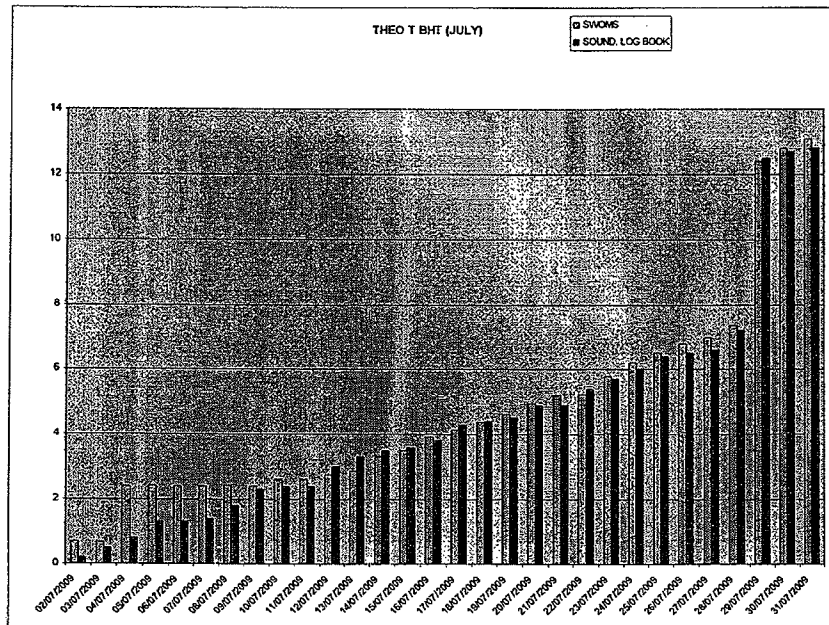
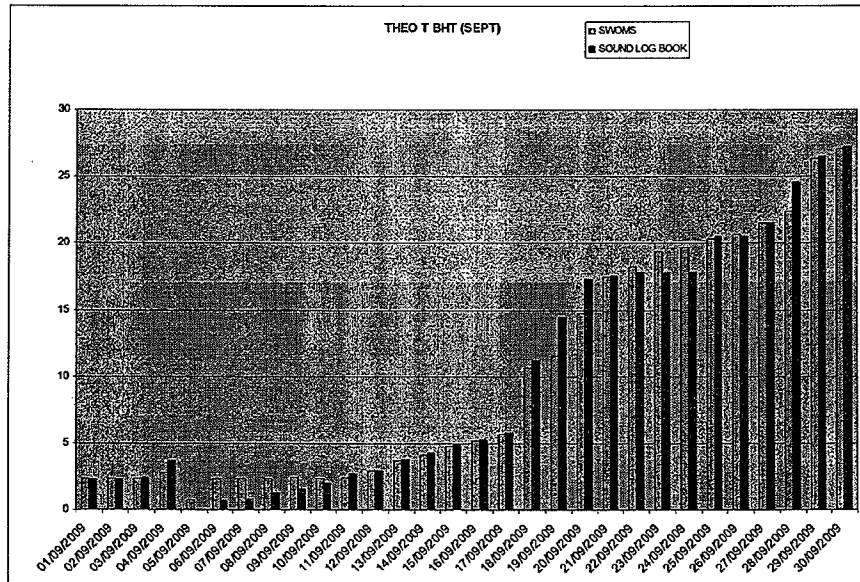
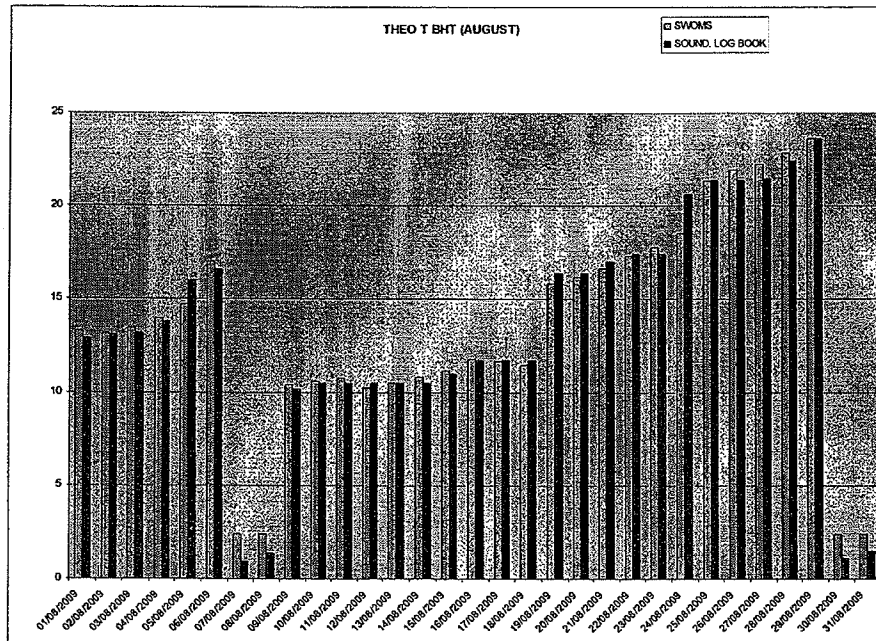
Figure 13 M/T THEO T – Bilge Holding Tank – July 2009

Figure 14 M/T THEO T – Bilge Holding Tank – August 2009

Figure 15 M/T THEO T – Bilge Holding Tank – September 2009

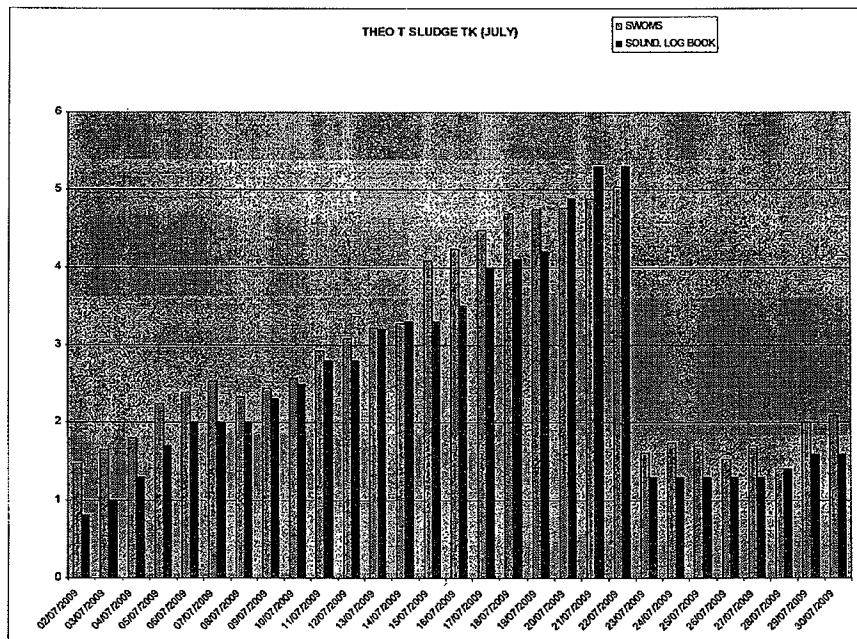
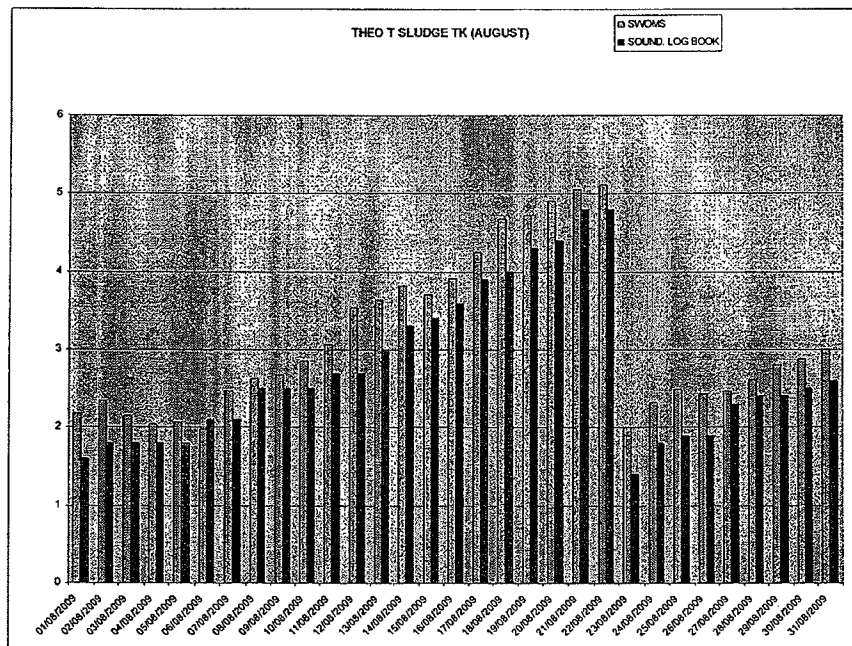
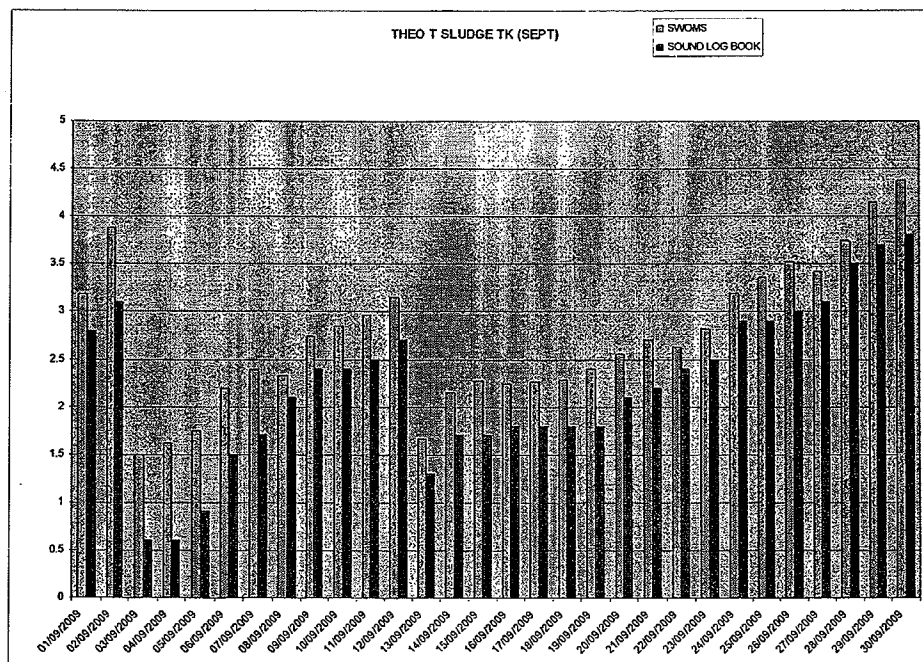
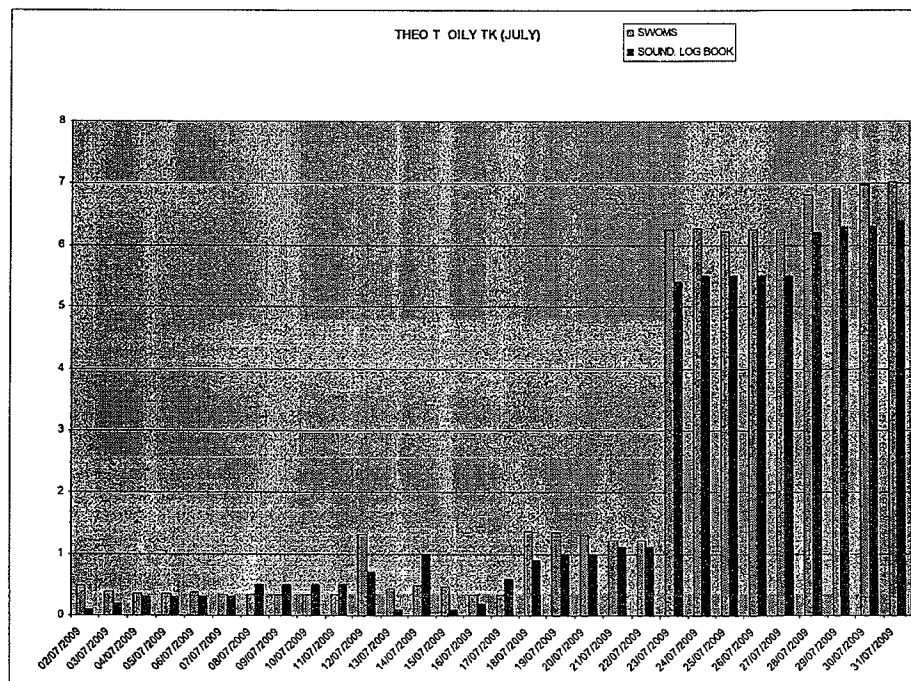
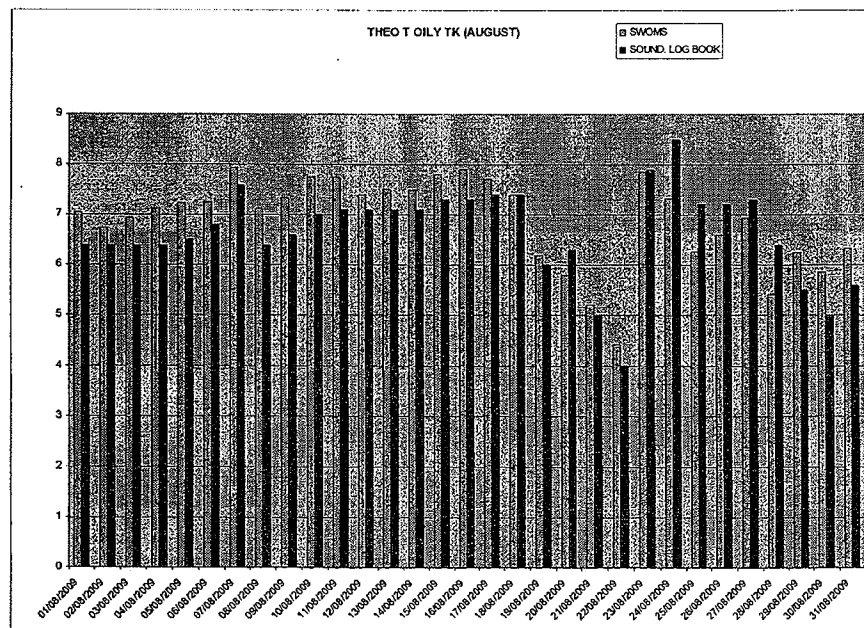
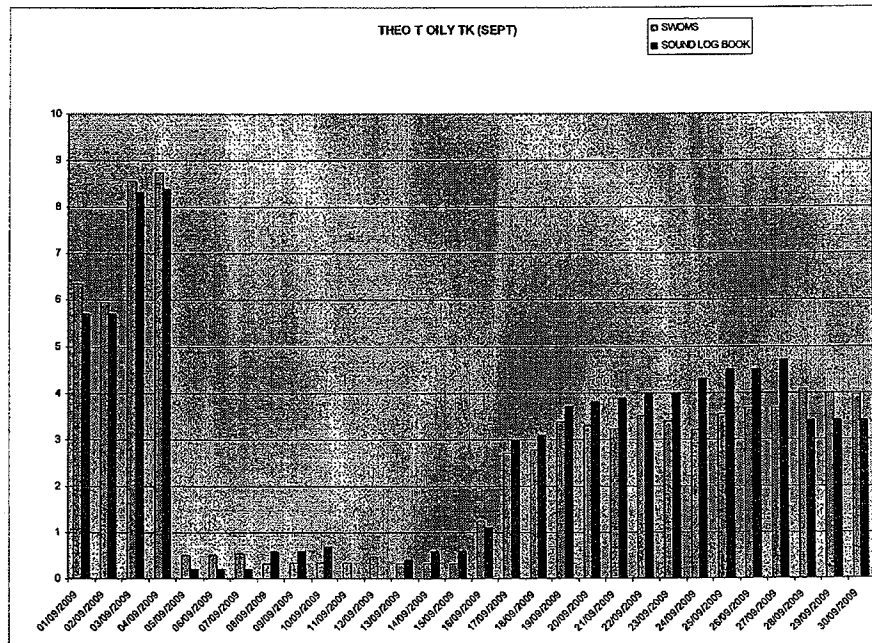
Minor discrepancies were found in soundings of the vessel's sludge tank by the SWOMS of approximately 2 – 7%. The technicians who boarded the vessel in July, 2009, were unable to resolve this particular minor discrepancy issue. However, the small percentage of the discrepancy is consistent with the normal operation of the vessel and the SWOMS inherent measuring error.

Figure 16 M/T THEO T – Sludge Tank – July 2009

Figure 17 M/T THEO T – Sludge Tank – August 2009

Figure 18 M/T THEO T – Sludge Tank – September 2009

Figure 19 M/T THEO T – Oily Bilge Tank – July 2009

Figure 20 M/T THEO T – Bilge Oily Tank – August 2009

Figure 21 M/T THEO T – Bilge Oily Tank – September 2009

- i) Discrepancies in readings that are attributed to the difference in times at when the soundings are carried out. The SWOMS records the tank levels at 00:00 GMT whereas the manual soundings are carried out during watch standing hours. During the period between the recording of the readings, transfers may have occurred resulting in the differences in recorded quantities. Please see, Figures 16, 17, 18, 19, 20 and 21.

In the event that Type (i) discrepancies are identified, the responsible Technical Superintendent cross checks that the manual soundings of the tank in question are within the maximum and minimum readings recorded by the SWOMS.

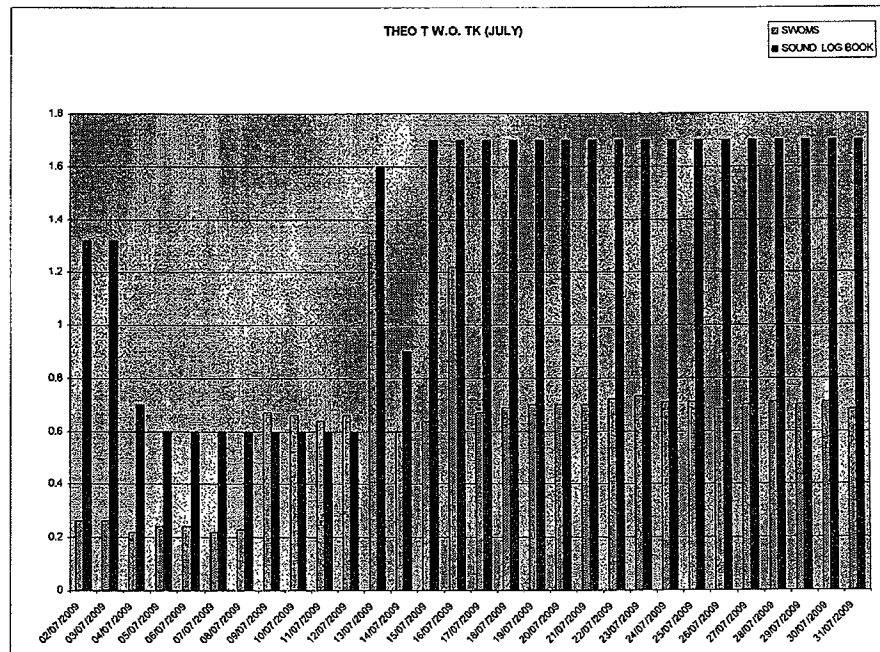
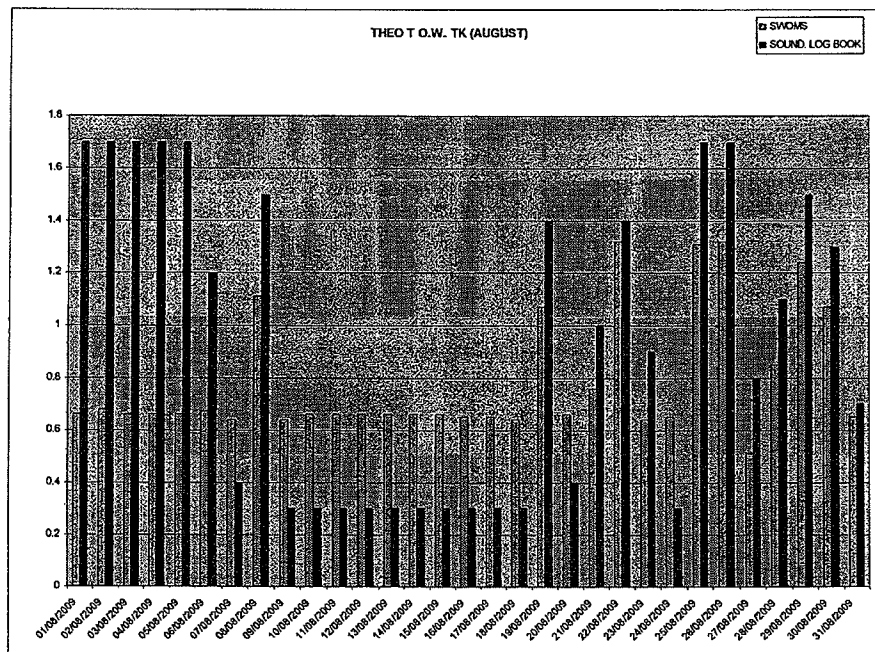
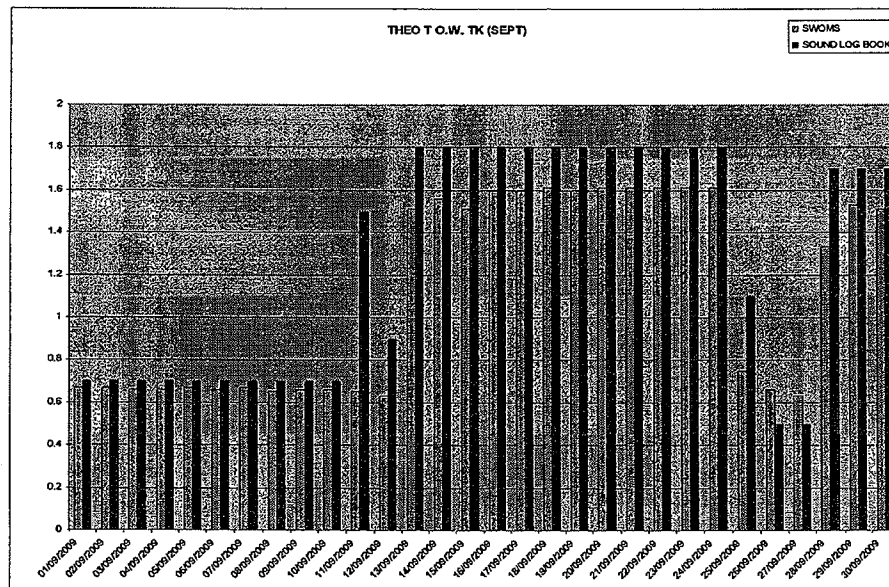
The same issue with the incinerator waste oil tank mentioned above for the M/T FIDIAS has been encountered on this vessel as well.

Figure 22 M/T THEO T – Waste Oil Incinerator Tank – July 2009

Figure 23 M/T THEO T – Waste Oil Incinerator Tank – August 2009

Figure 24 M/T THEO T – Waste Oil Incinerator Tank – September 2009

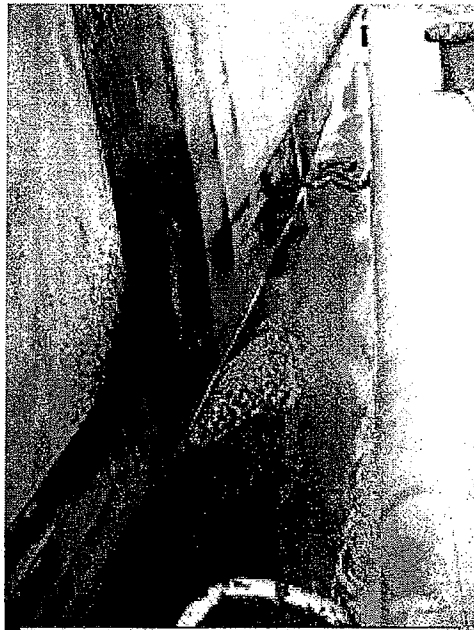
The oil pollution response team placed booms around the fore and aft of the vessel in order to contain the oil sheen.

M/T KRITON - STBD SIDE - BOOMS IN PLACE

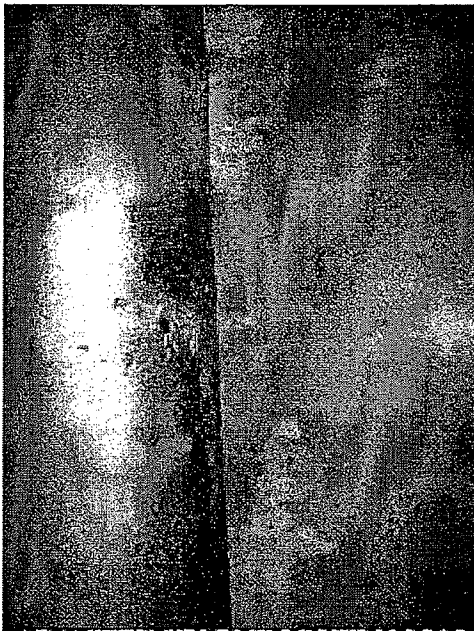
It was verified that fuel oil was leaking from the Oil Discharge Monitoring Equipment (ODME) discharge pipe's overboard that passes through the vessel's fuel oil tank.

EXTERNAL VIEW OF ODME DISCHARGE PIPE

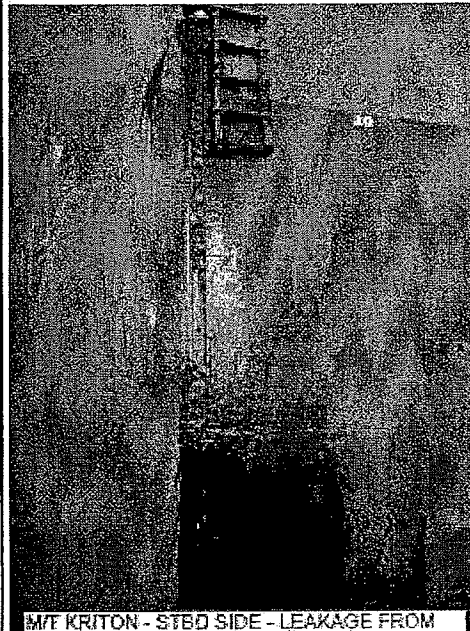
At 08:30 LT, the 3<sup>rd</sup> Officer observed oil in the dock water on the starboard side of the vessel between the dock and the vessel. The gangway watch notified the Chief Officer who immediately sounded the alarm. Bunkering operations were immediately terminated and the oil pollution response team was activated.

M/T KRITON - STBD SIDE - LEAKAGE FROM  
ODME OVERBOARD

In order to ensure no additional oil was discharged outside the vessel, the Chief Officer began to transfer ballast from the vessel's starboard side to the port side, while the Chief Engineer began transferring fuel oil from the starboard fuel oil tank to the port fuel oil tank.
