M/T PLOUTOS
ON-GOING ENVIRONMENTAL AUDIT
ARABIAN GULF
SEPTEMBER 07-12, 2010

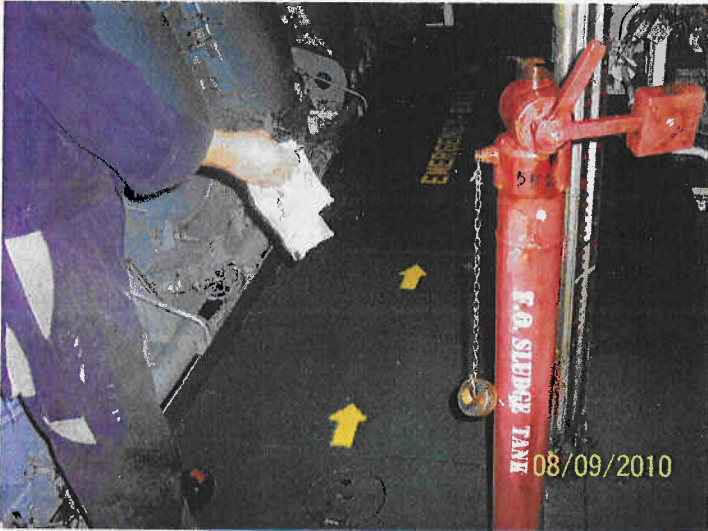
9/8/2010
19 Manual sounding FO sludge tank.JPG

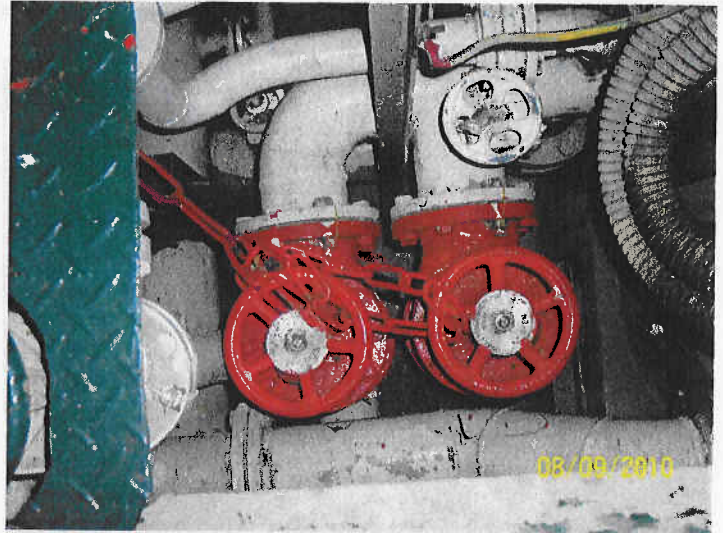
9/8/2010
01 Valves chained and sealed.JPG

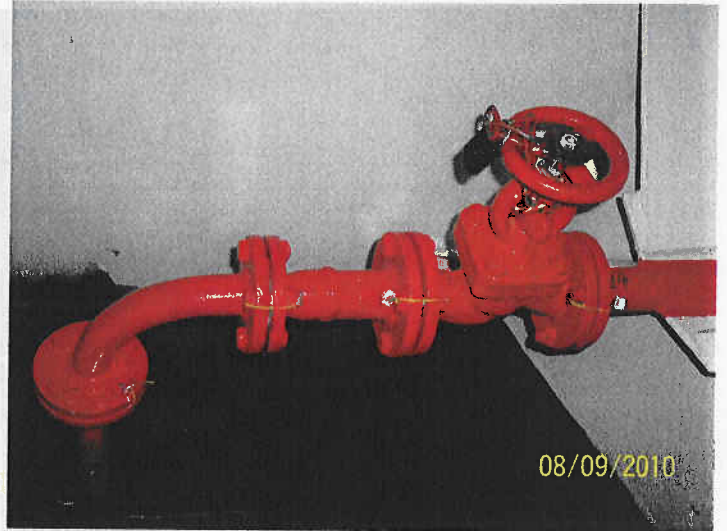
9/8/2010
09 OVB valve locked & sealed.JPG

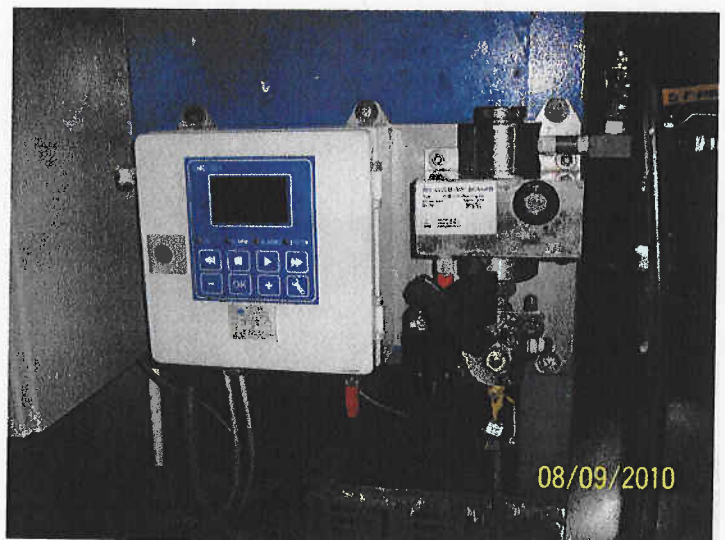
9/8/2010
03 OCM with seals on sampling line.JPG

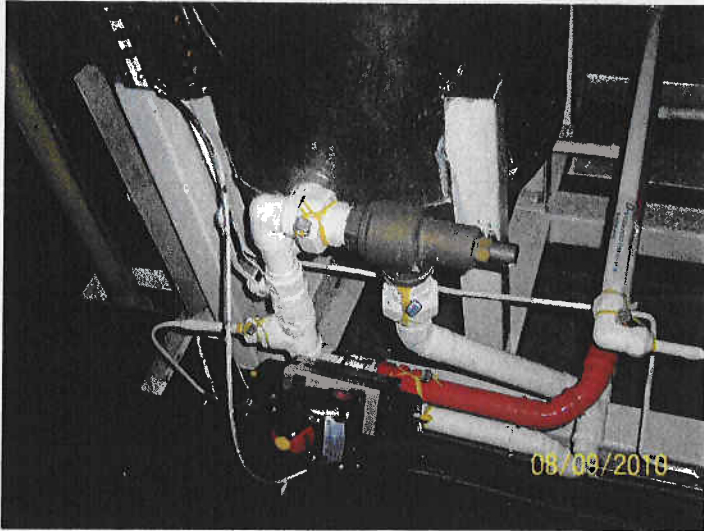
9/8/2010
04 Three-way valve with seals & recirculation piping.JPG

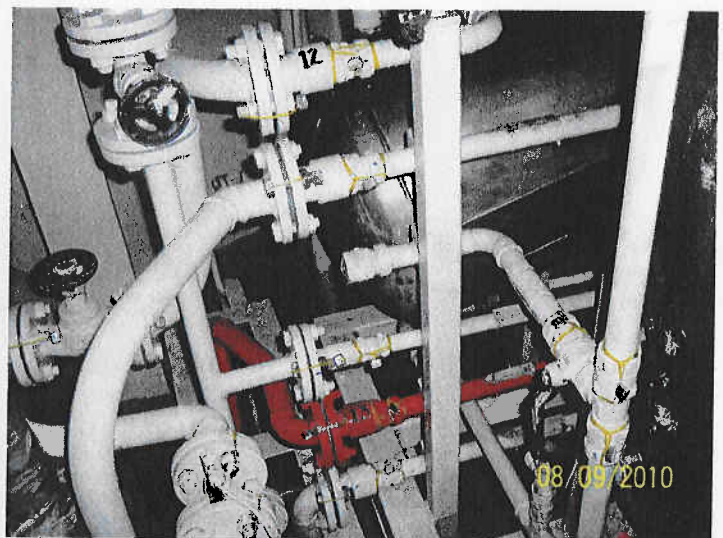
9/8/2010
07 OWS piping with seals.JPG

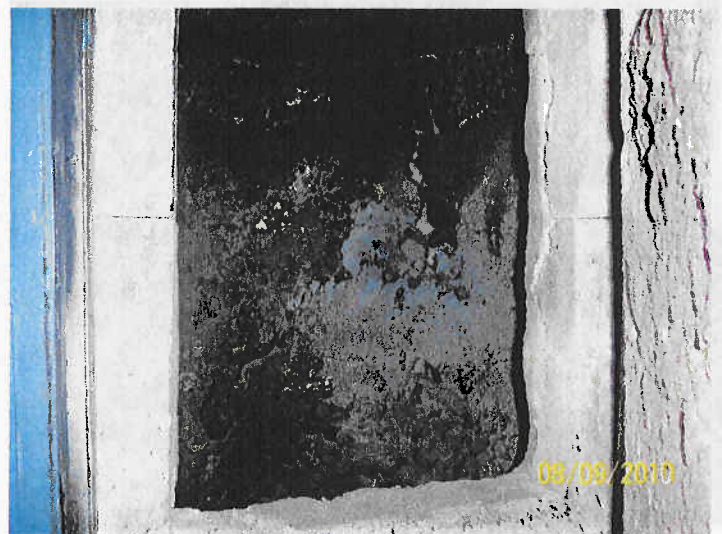
9/8/2010
02 Furnace condition.JPG

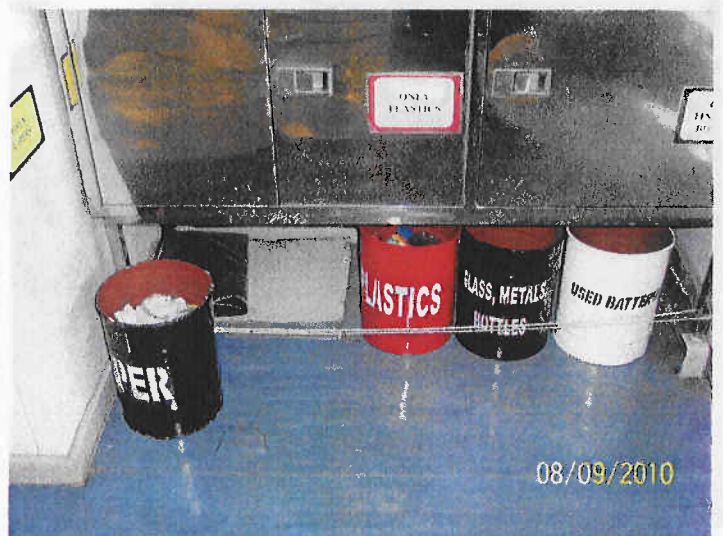
9/8/2010
11 Mixed containers for garbage.JPG

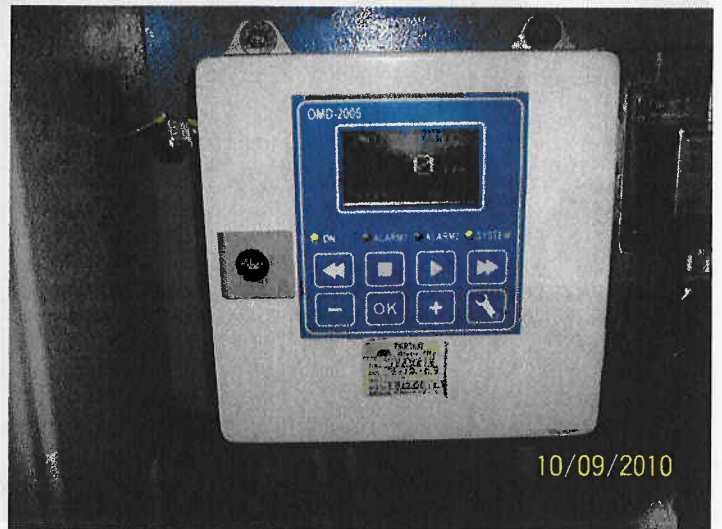
9/10/2010
18 ZERO reading on OCM at end of test.JPG

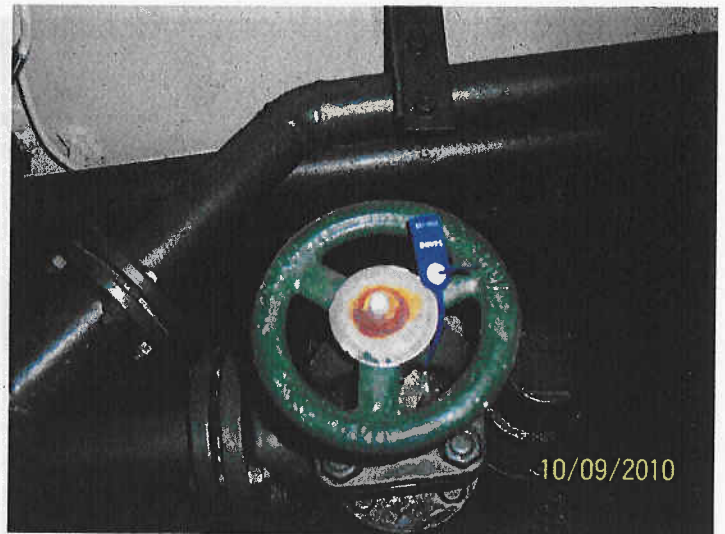
9/10/2010
03 Pump room seals.JPG

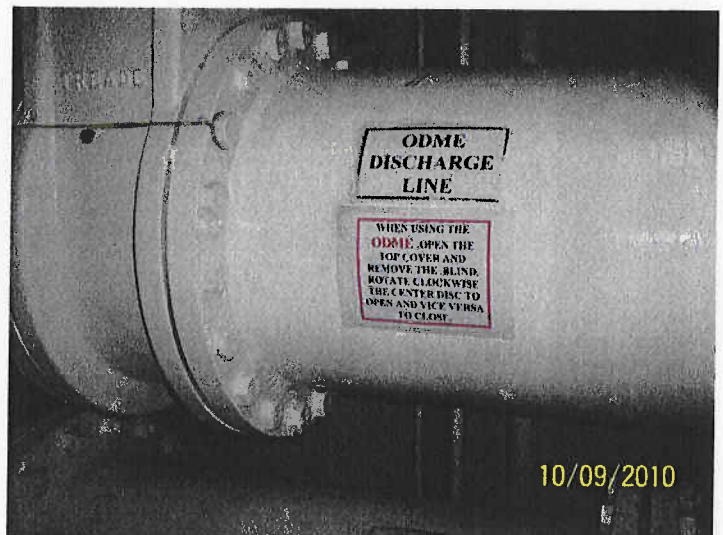
9/10/2010
05 ODME discharge line flange sealed.JPG

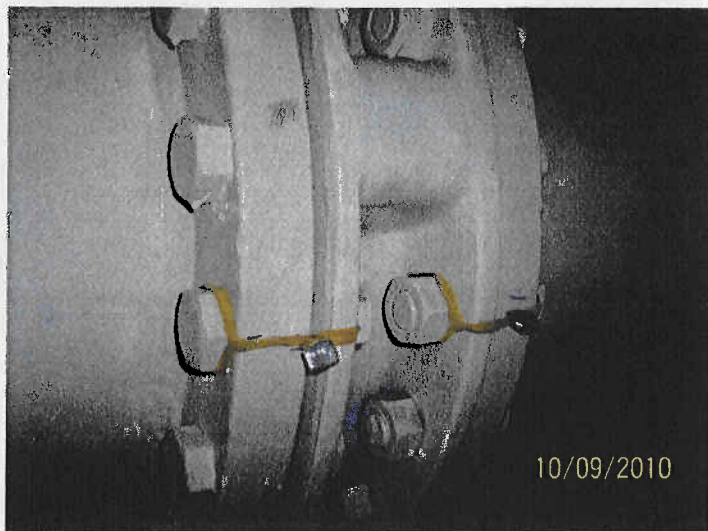
9/10/2010
07 ODME pumproom line flanges sealed.JPG

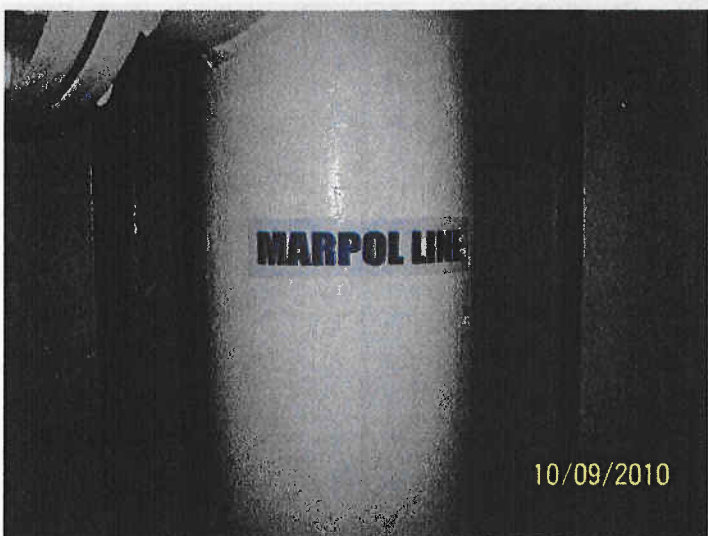
9/10/2010
08 MARPOL line marked.JPG

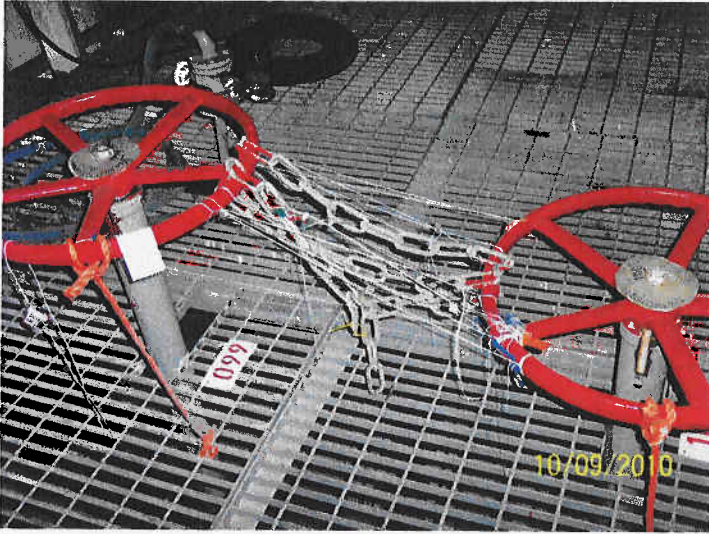
9/10/2010
10 Pump room valves chained.JPG
