Re: *United States v. Ionia Management S.A.*  
Index No. 07-cr-134 (JBA)  
Response to Special Master's Letter, dated November 11, 2009  
CO&D Ref: 500172.0002

## Report of Ionia's Progress – December, 2009

**3. Pollution incident, 17 September, 2009 at Antwerp. The issues from the Antwerp incident to be addressed include:**

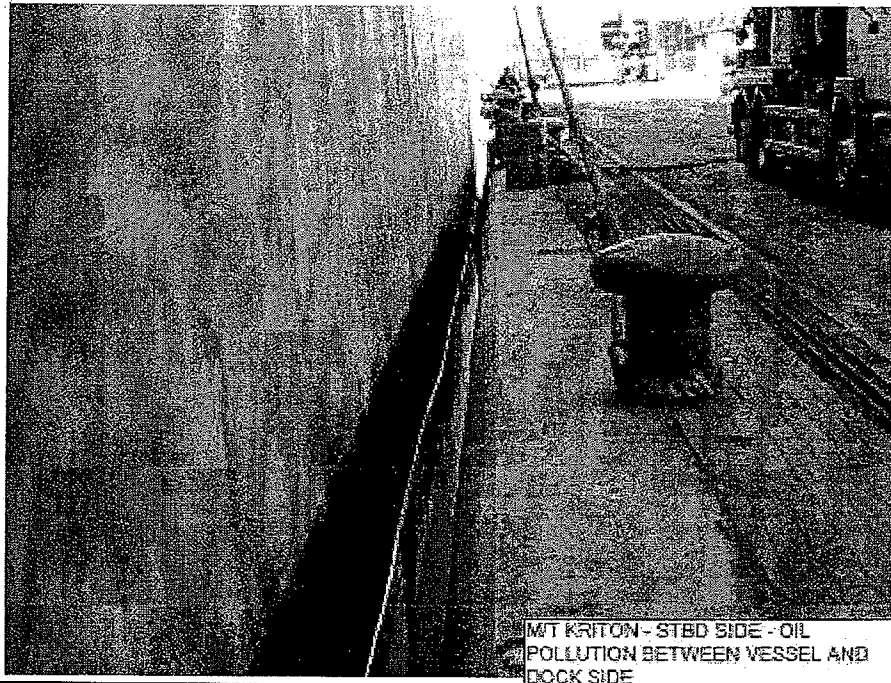
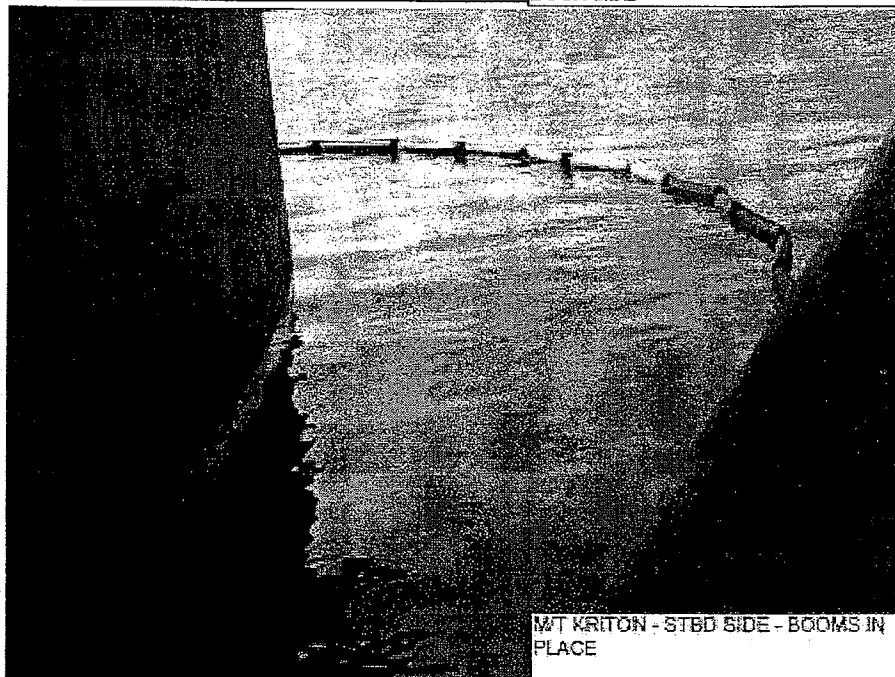
**Figure 26 M/T KRITON – Pollution Incident at Antwerp**

It was verified that fuel oil was leaking from the Oil Discharge Monitoring Equipment (ODME) discharge pipe's overboard that passes through the vessel's fuel oil tank.
