M/T PLOUTOS
ON-GOING ENVIRONMENTAL AUDIT
ARABIAN GULF
SEPTEMBER 07-12, 2010

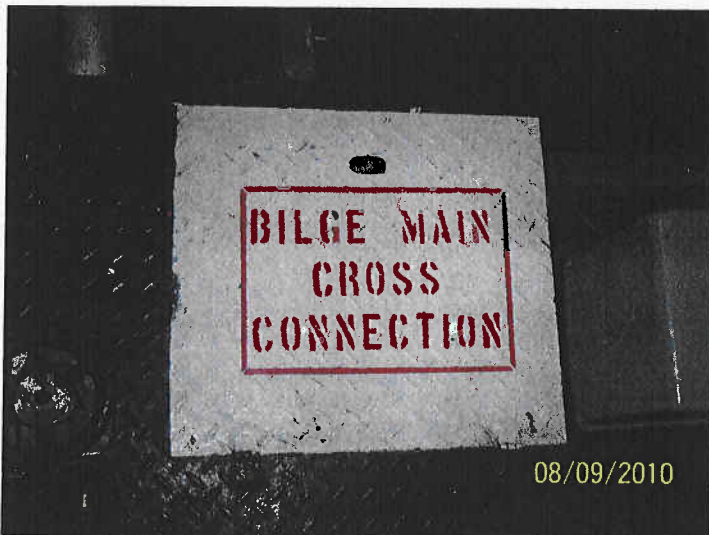
9/8/2010
01 Emerg. Bilge crossover.JPG

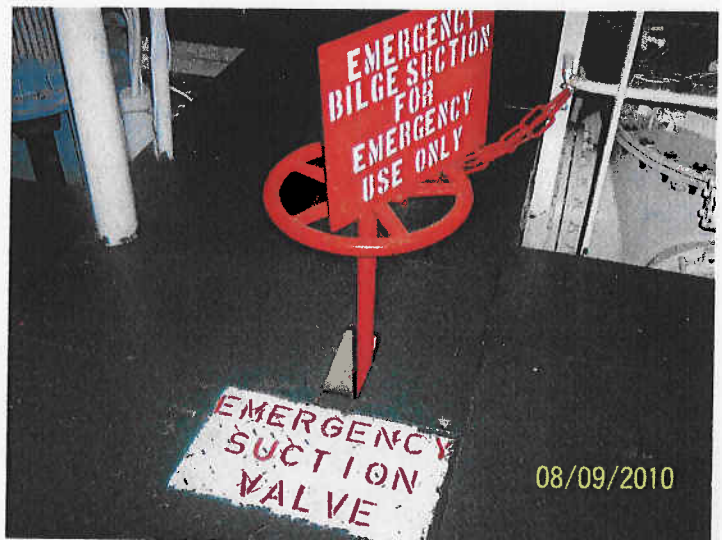
9/8/2010
03 Emerg. Bilge suction.JPG

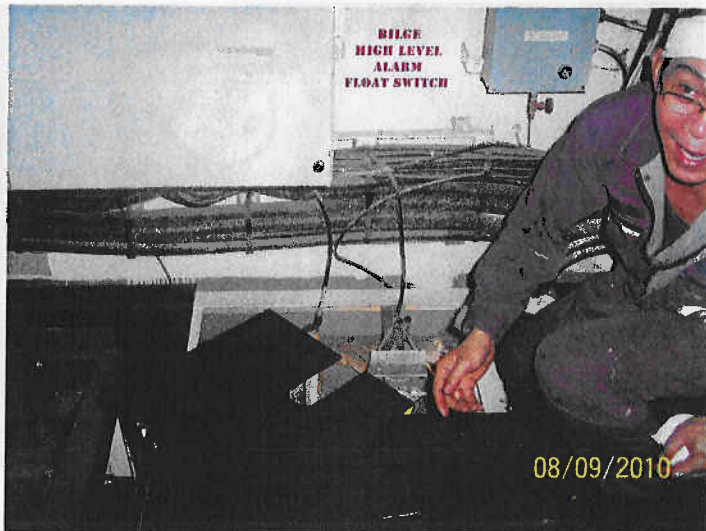
9/8/2010
20 Testing for'd bilge alarm.JPG

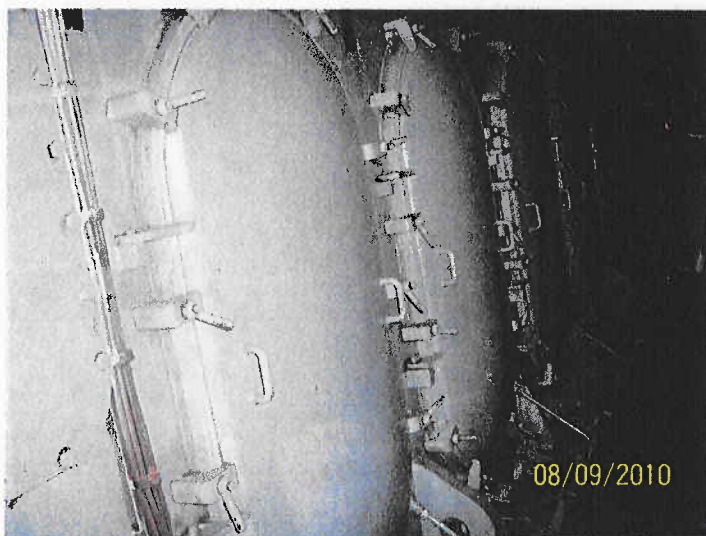
9/8/2010
02 ME crankcase.JPG

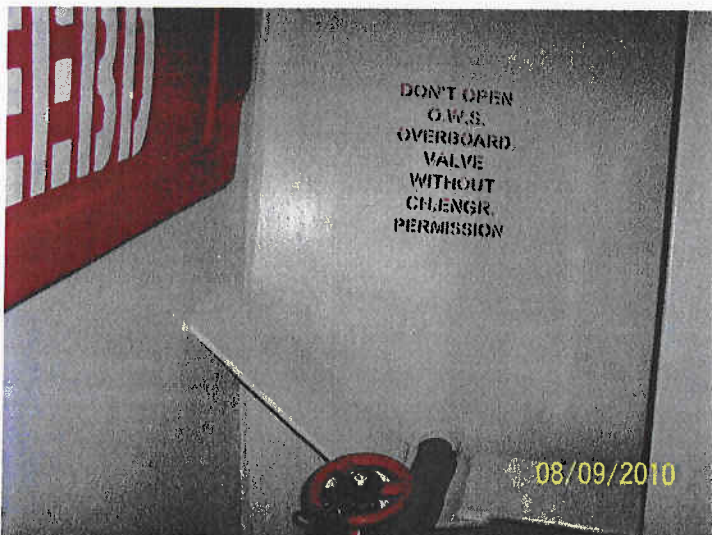
9/8/2010
13 OVB valve notice.JPG

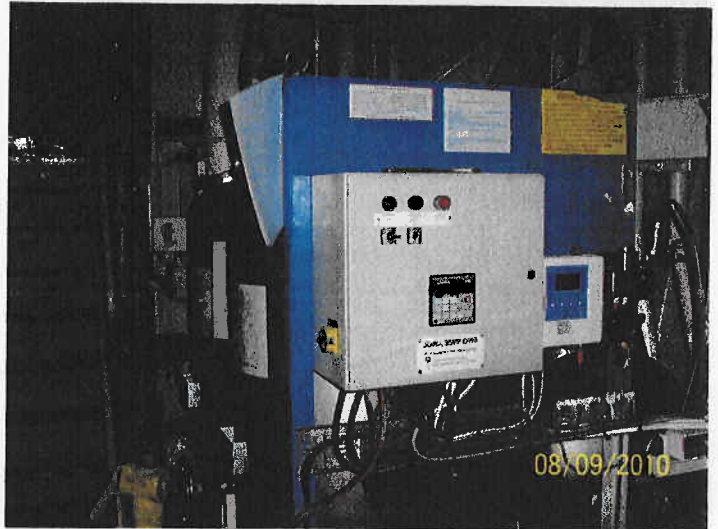
9/8/2010
05 OWS MEPC 107(49).JPG

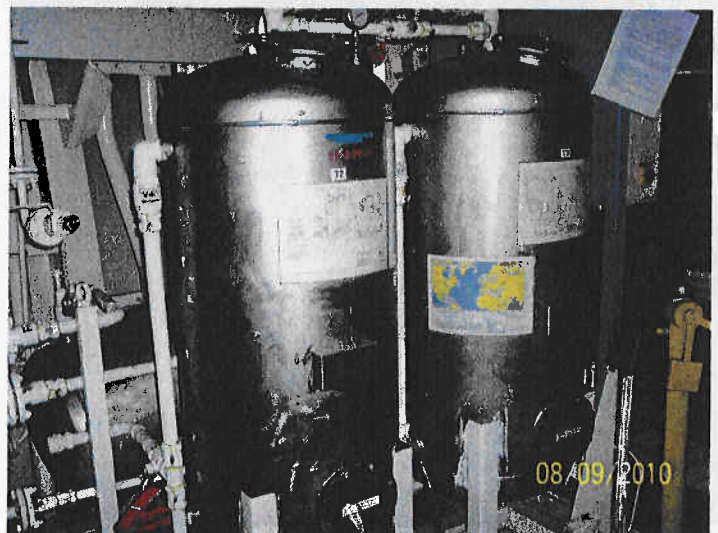
9/8/2010
01 OWS.JPG

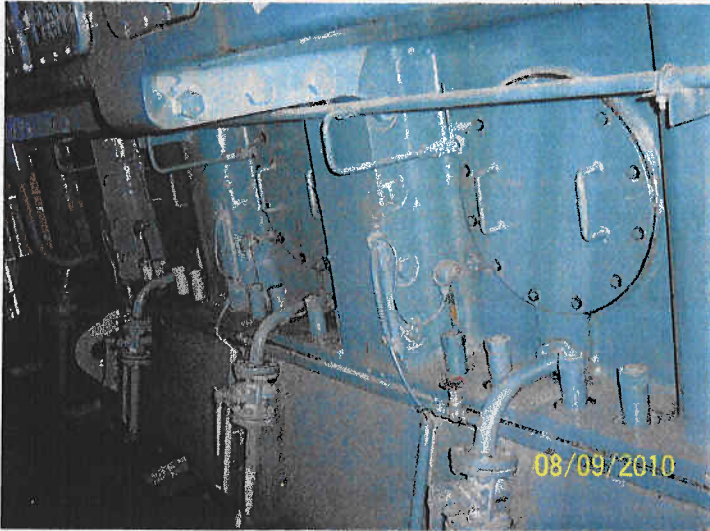
9/8/2010
03 ME crankcase.JPG

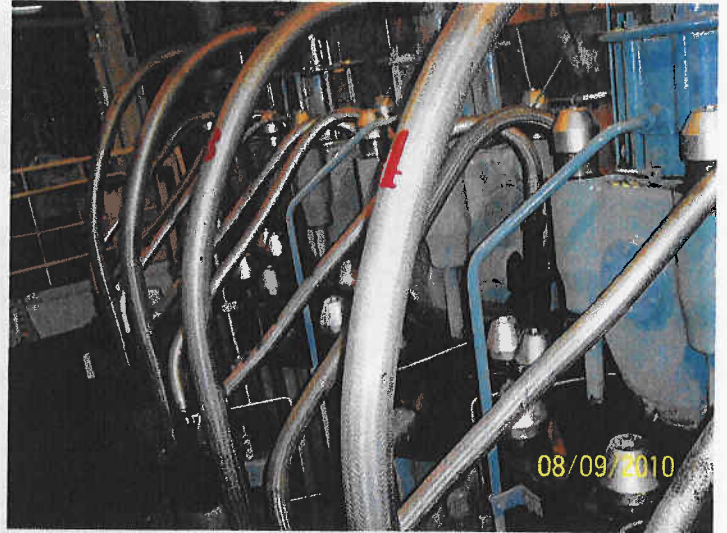
9/8/2010
01 ME.JPG

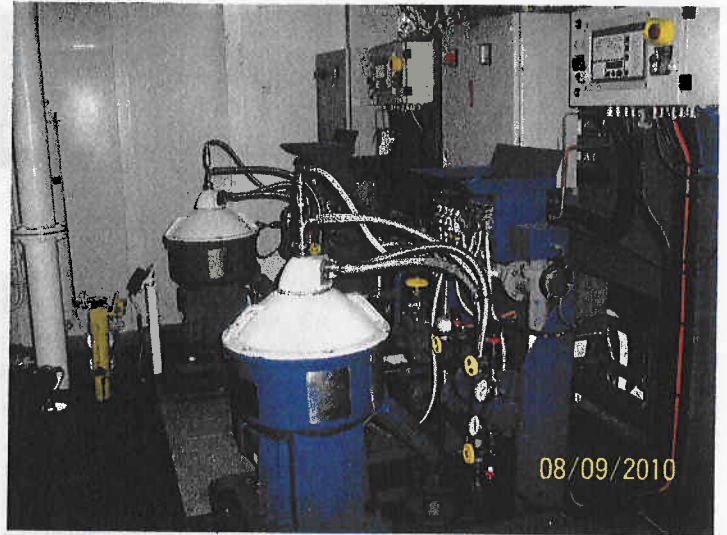
9/8/2010
 02 LO purifiers.JPG

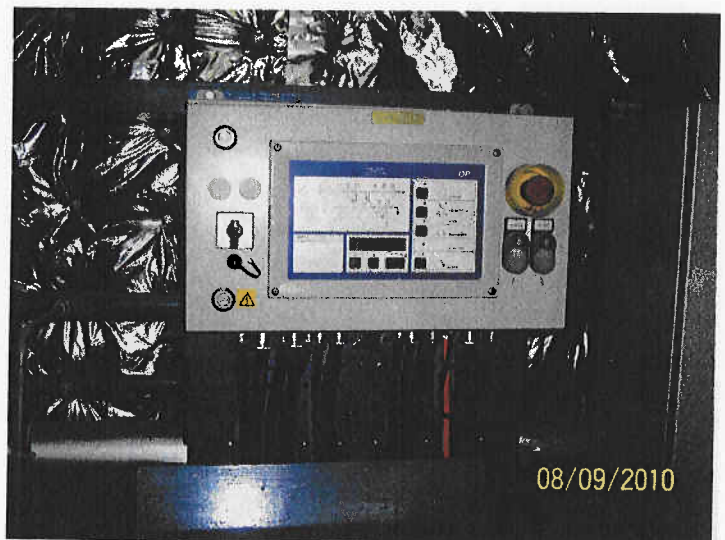
9/8/2010
 03 Purifier setting panel.JPG

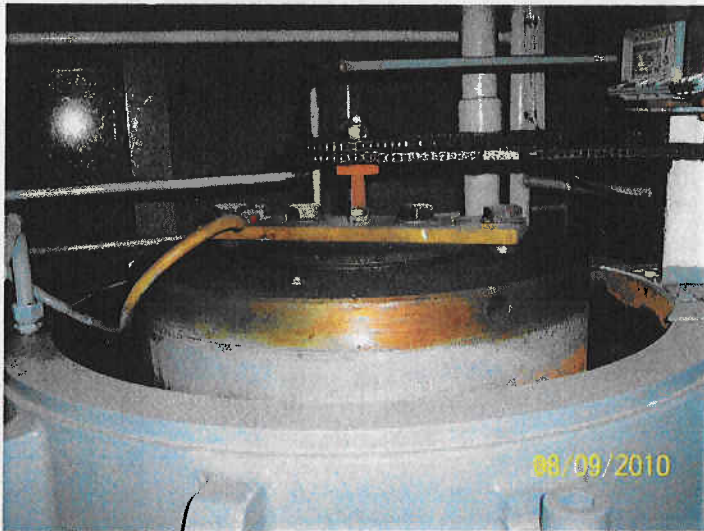
9/8/2010
05 Steering engine.JPG

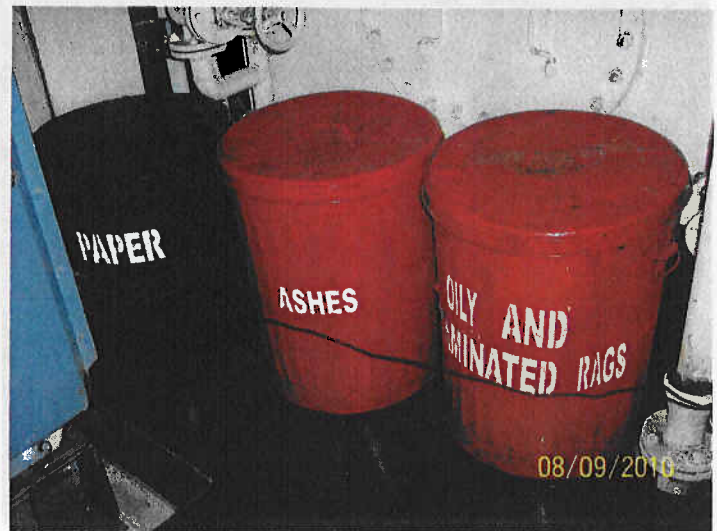
9/8/2010
08 ER garbage collection.JPG

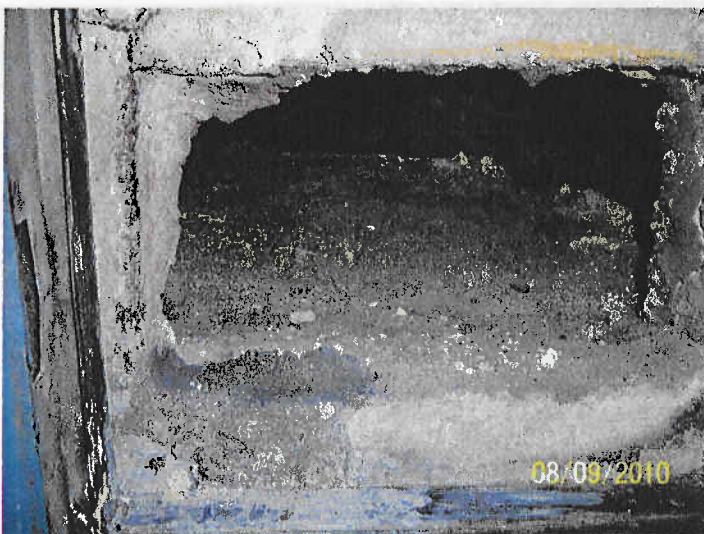
9/8/2010
01 Incinerator furnace.JPG

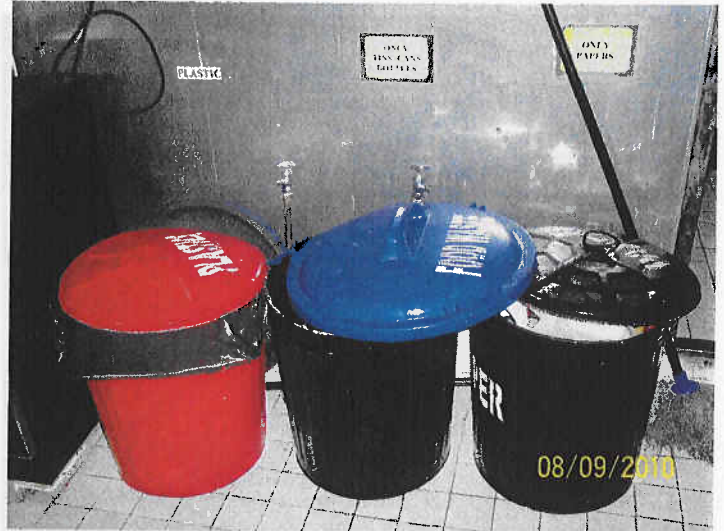
9/8/2010
 03 Pantry Crew.JPG

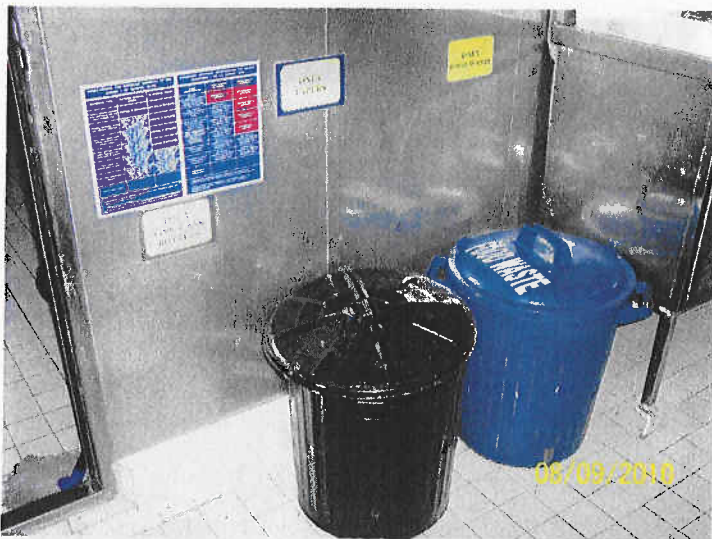
9/8/2010
 04 Pantry officer.JPG

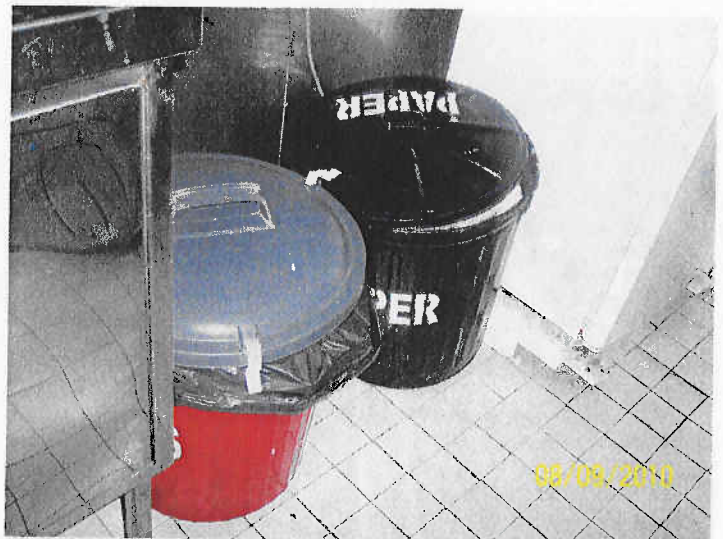
9/8/2010
 05 Pantry officer.JPG

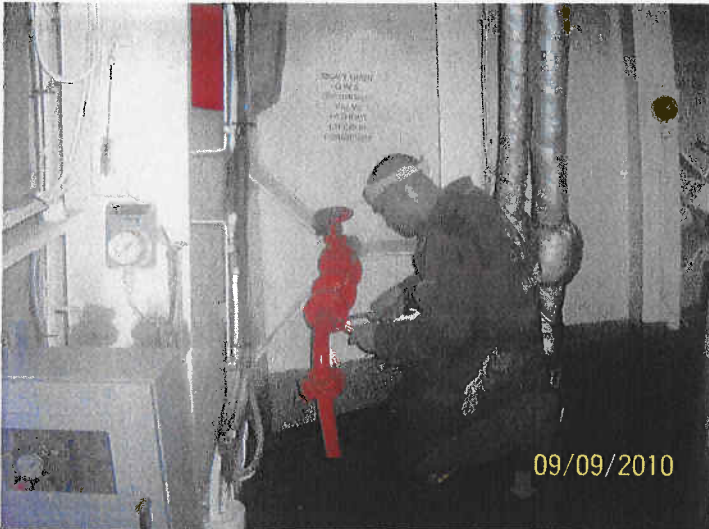
9/9/2010
10 Opening adjacent valve pipe for inspection.JPG

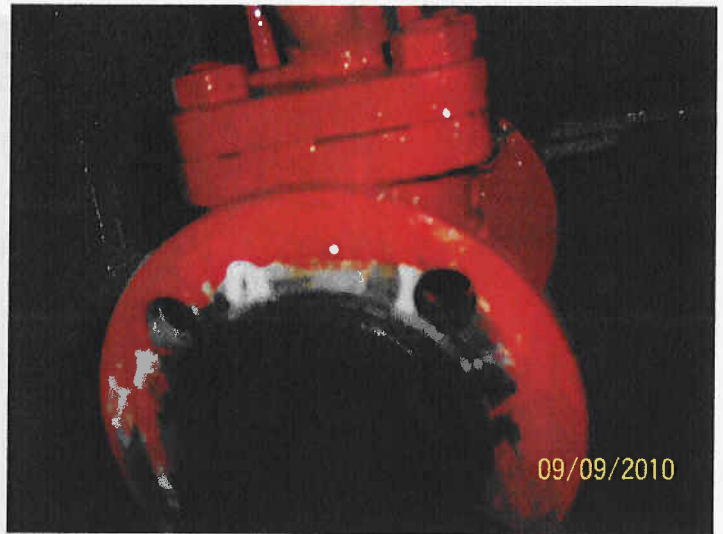
9/9/2010
11 OVBD valve end.JPG

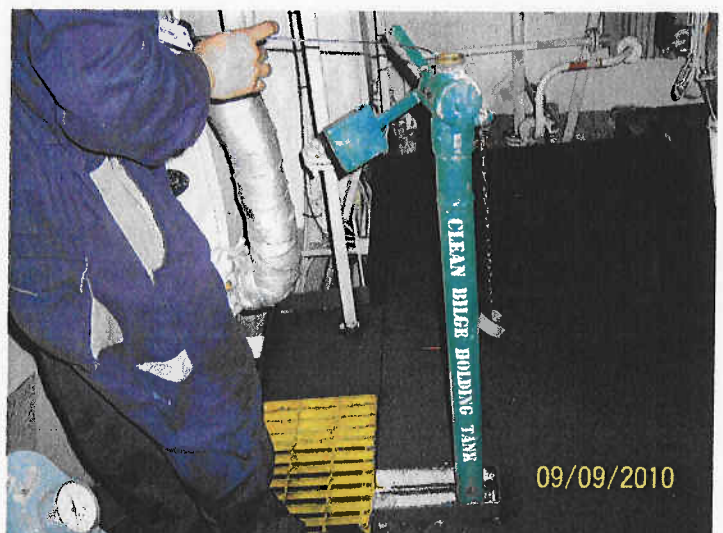
9/9/2010
15 Source tank sounding.JPG

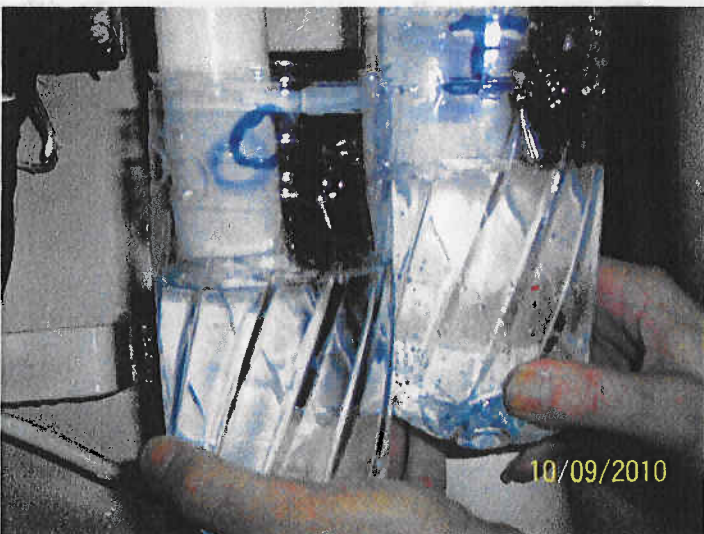
9/10/2010
17 Last in & out samples.JPG

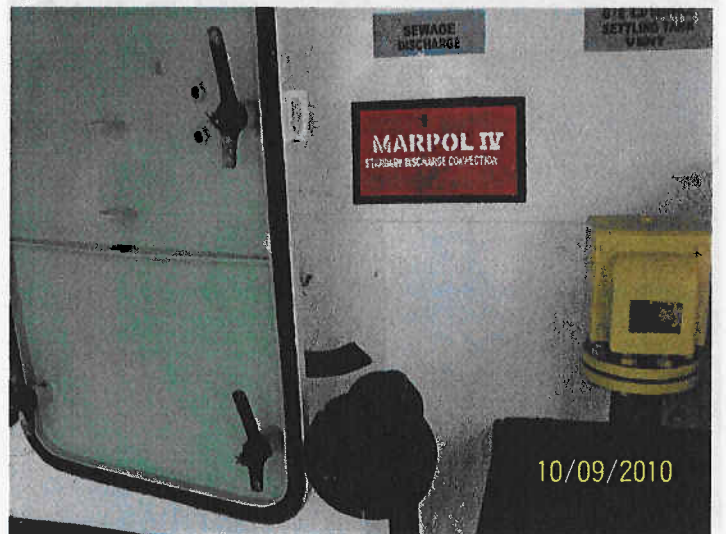
9/10/2010
01 Sewage OVBD STD valve.JPG

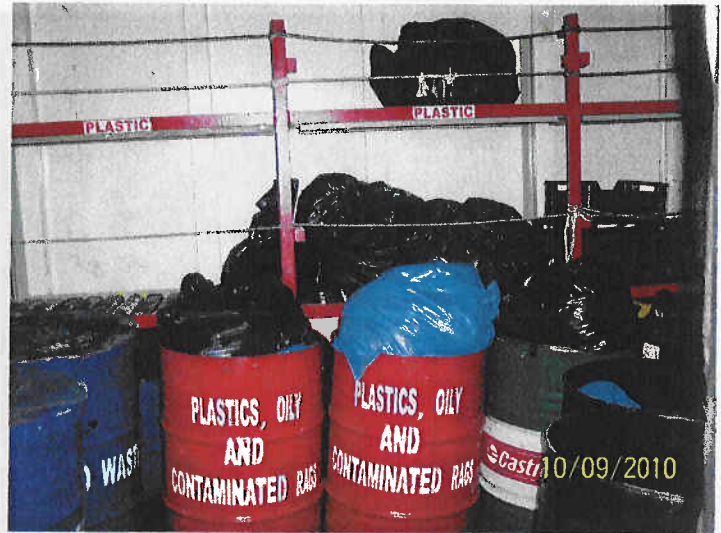
9/10/2010
 07 Main Deck garbage locker.JPG

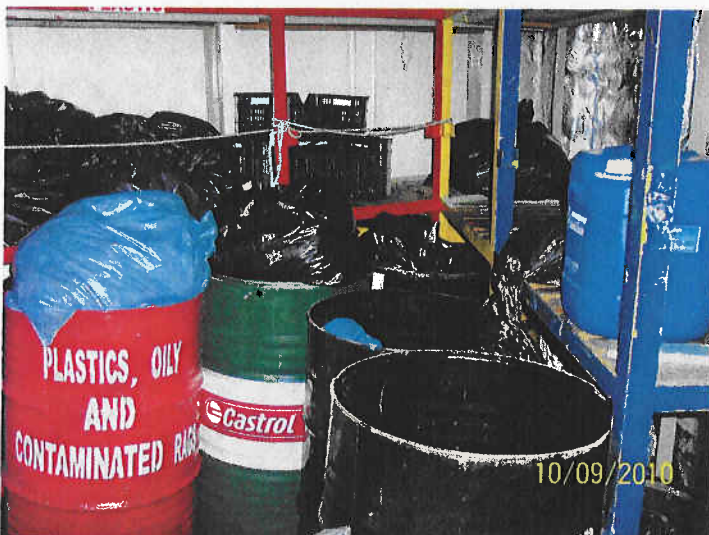
9/10/2010
 06 Main deck garbage locker.JPG

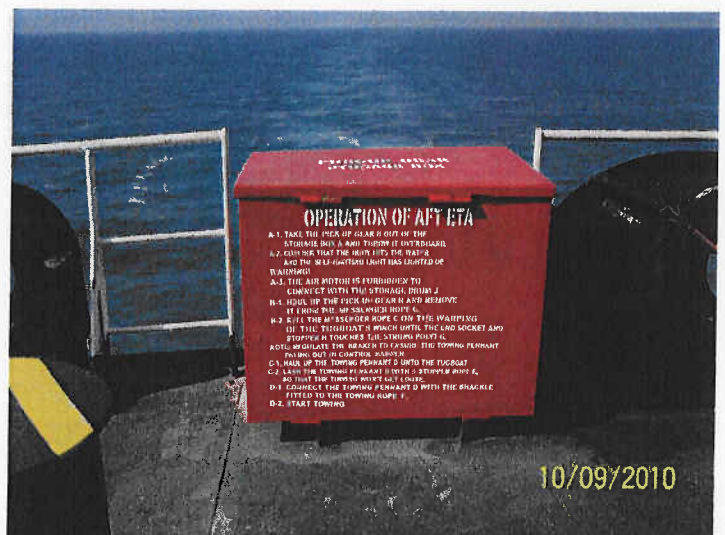
9/10/2010
 01 Emerg. Towing aft.JPG

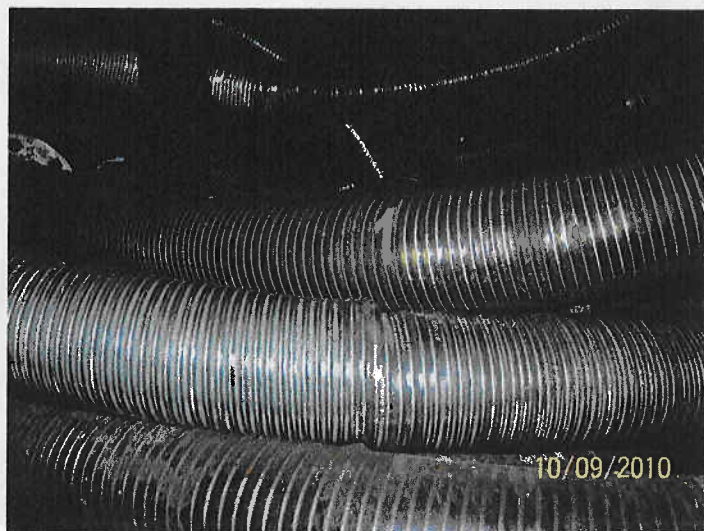
9/10/2010
01 Flex hose numbered.JPG

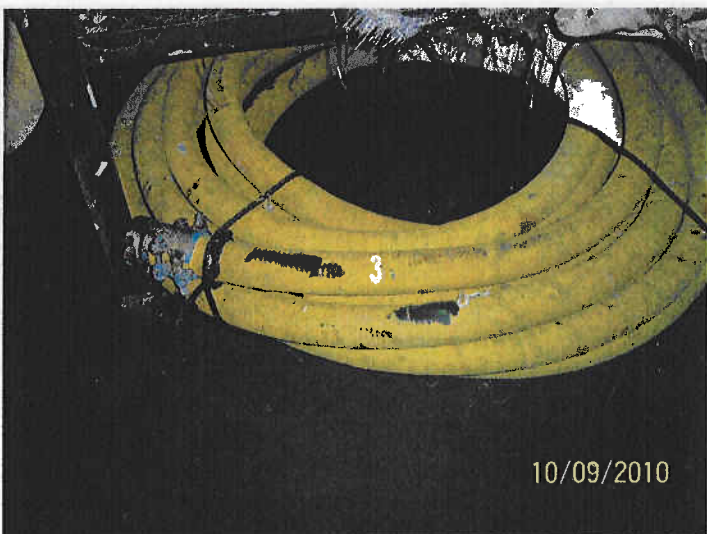
9/10/2010
02 Flex hose for'd store.JPG

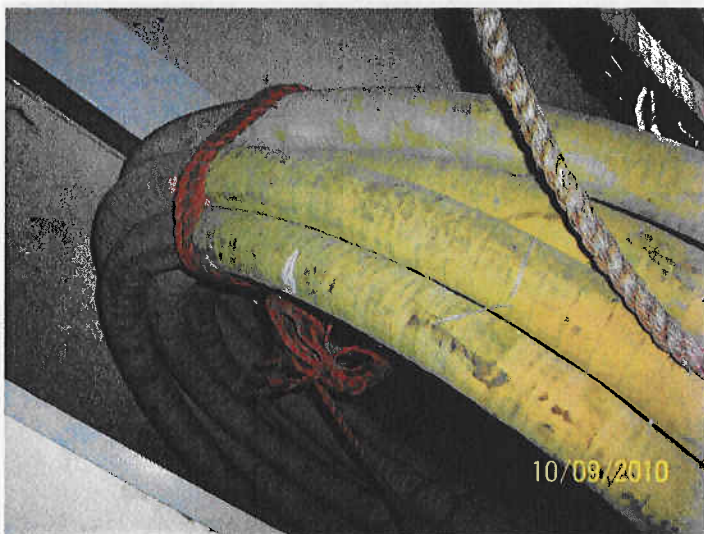
9/10/2010
03 Flex hose for'd store.JPG
